# THE INCIDENTS OF BRIDGES AND ROADS AT PLAIN OF REEDS - VIETNAM AND SUGGESTED SOLUTIONS

NGUYEN THANH NGUYEN

Ho Chi Minh City Open University, Vietnam – thanhnguyen@longan.gov.vn

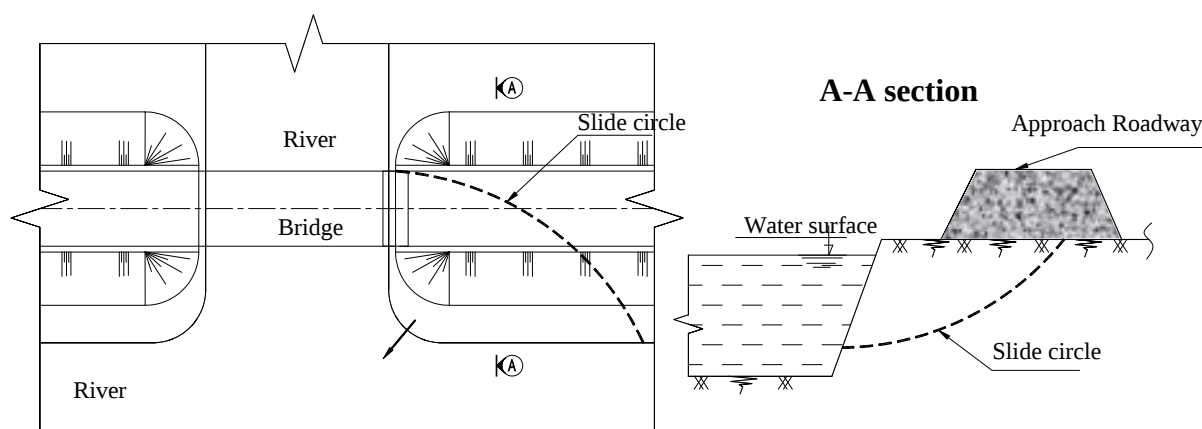
**Figure 2.** Slide circle of approach roadway

➤ In the Plain, because there are many rivers and canals, the density of bridges is very high; in average, the distance of two bridges is 1km. The bridges are usually posed at confluence; because of weak soil, the high approach roadway causes easily two demension land slide (see figure 2). While, the Plain is an anual high flood area of Mekong Delta, so the approach road ways are always built much more higher than the natural earth's surface to assure clearance of bridge span and flood level; this is the addition cause of construction incidents.

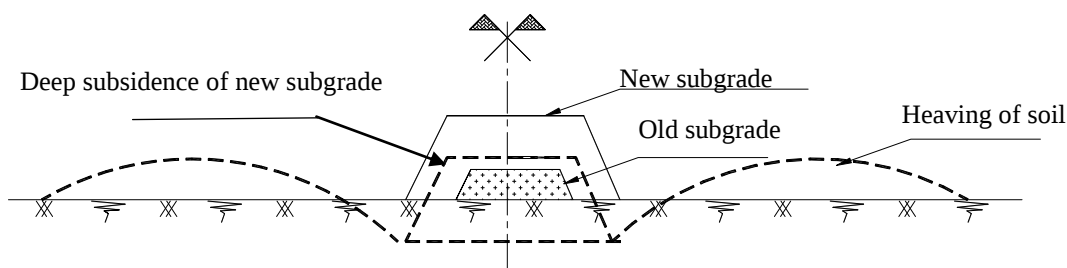
**Figure 3.** Deep subsidence of subgrade with heaving of soil

- Incident description: the road was upgraded from the old construction which was built hundred years ago, and there was no elaborate geological survey. The medium elevation of old road bed surface was +1.5, the structure of road was graded aggregate, pavement width 4m, subgrade width of 6m. The new road had +4 high level, graded aggregate pavement, 6m of pavement and 9 m width of subgrade. After 6 months of finish, the subgrade subsidence was 1m and 1 year later it reached 1.5m. The incident occurred on a distance of 200m and this hindered the traffic, especially in the flood season of 2000-2003 (see figure 3). The resurvey shows that the layer of mud clay layer is very thick and the added height of fill is 2.5m.

➤ Option 2: it is needed to build 'anti pressure fill' in two sides of incident road (each side 20m, elevation +3). The method accepted subsidence and added fill. This way had low cost but the recovery time was rather long, and it had to accept traffic inconvenience of frequent fill work (see figure 4).

- Treatment result: because of many reasons, especially of cost, the 'anti pressure fill' was chosen. After about 1 year of treatment, the subsidence diminished gradually and after 2 years, the construction was stable and well exploited.

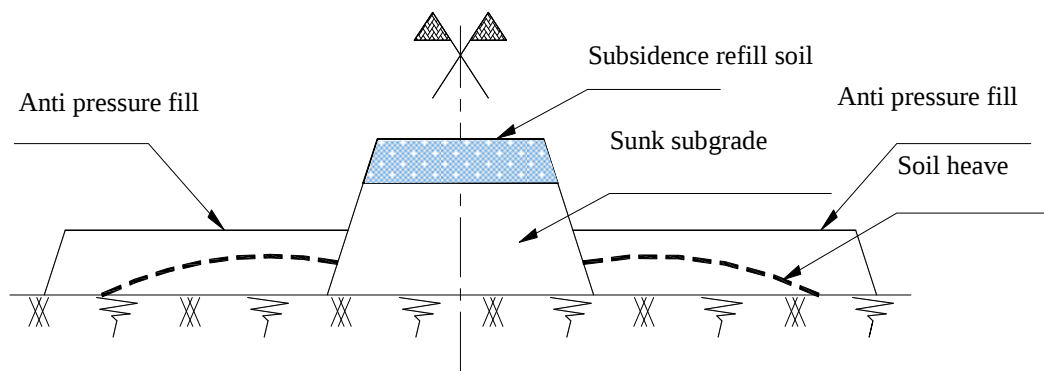
**Figure 4.** Deep subsidence subgrade treatment

- Description: the road was designed as new construction and situated far of river, the width of subgrade and pavement was 9m and 6m; this area has weak soil with peat and mud clay, its thickness is about 20m. During construction, the fill caused subsidence and the soil heaved two sides of road, the volume of subgrade work increased double to previous calculation. After one year of

accomplishment, the subgrade sank more than one meter.

- Treatment method: because of finance difficulty, 'anti pressure fill' method was used. They filled by soil for 20m each side and the elevation was +2 to the natural land level. When the subgrade sank about 0.4 meter, they continued to fill to assure the pavement level for traffic and anti-flood. After one year of treatment, the subgrade became stable and the construction was exploited normally (see figure 4).

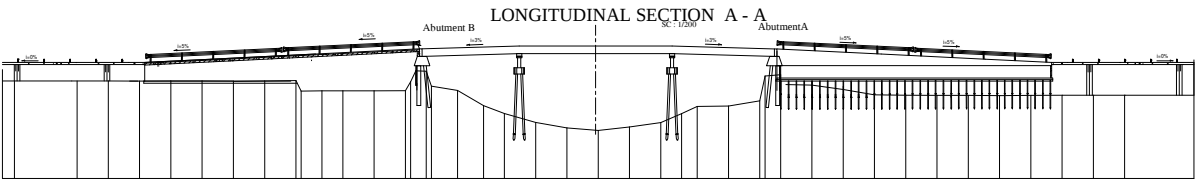
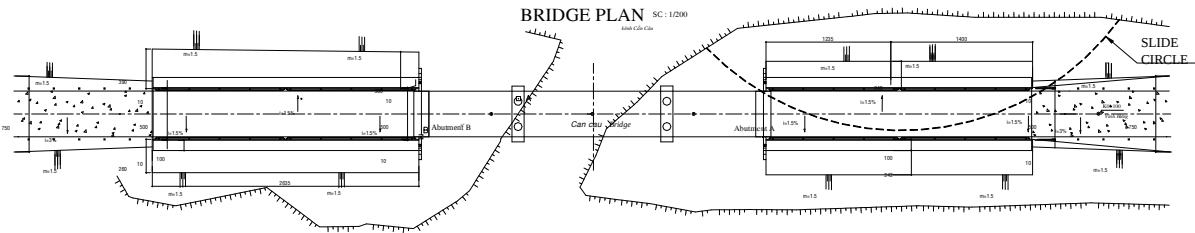
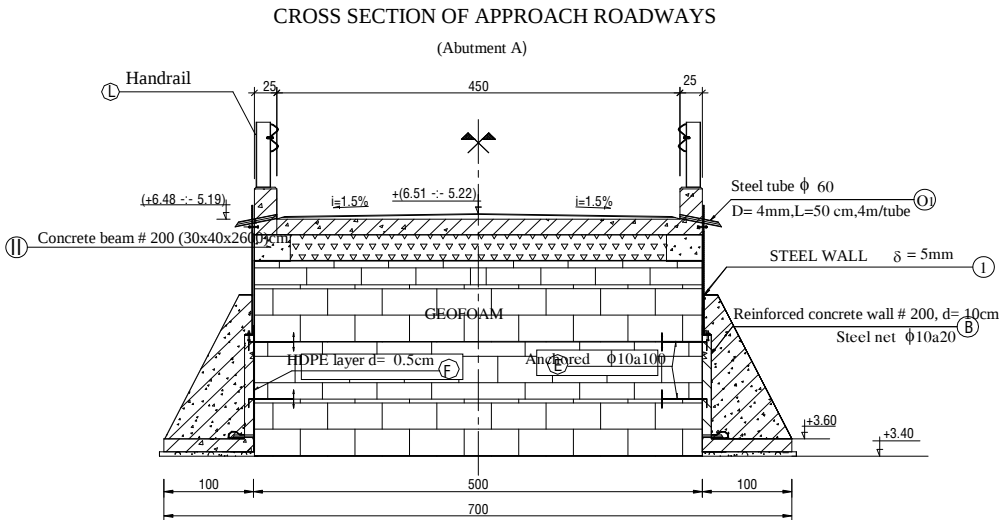
- At first, the ferroconcrete bridge was designed and constructed at the cross of two canals. It had following features: width 5m, spans 10-15-10m. The approach way had elevation of +6.5 at abutment (natural land level is +2.1). The soil condition is very weak with the mud clay layer is more than 17m. When the approach way was constructed to +5 level, the land slide of two side slide circle appeared at A abutment.

- The first treatment: after the incident, they determined that there were three reasons: charge of approach way, weak geological condition and the construction was situated near the canals' bank. The consultant enterprise proposed a solution to treat the land slide by changing heavy soil fill by lighter substance. They changed all embankment soil

( $\gamma=1,4-1,5t/m^3$ ) by Geofoam, a light material that had natural weight of  $33kg/m^3$ , modulus of elasticity of bulk  $E=7650$ , compressive strength  $79Kpa$ , flexural strength of  $350 Kpa$ . This light material was protected by HDPE and the steel wall of 5mm (see figure 5-7). After treatment end, this light structure of A abutment continued to slide into the canal. A year later, they discovered that although there was a big load diminishing of approach way, the layer of Biofoam was soaked by flood and rain so their weight increased, in addition with 0.5 m of sand fill and old slide circle, the same incident continued to occur.

Figure 5. Longitudinal Section of Can Cau bridge first treatment

Figure 6. Plan of Can Cau bridge first treatment

Figure 7. Cross section of approach road way of first treatment

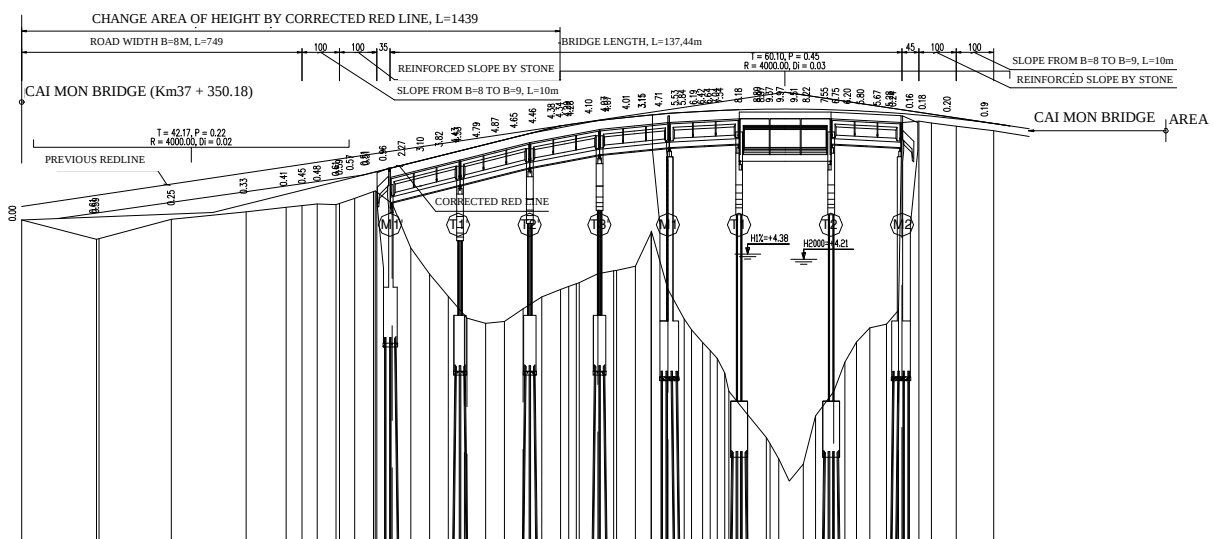
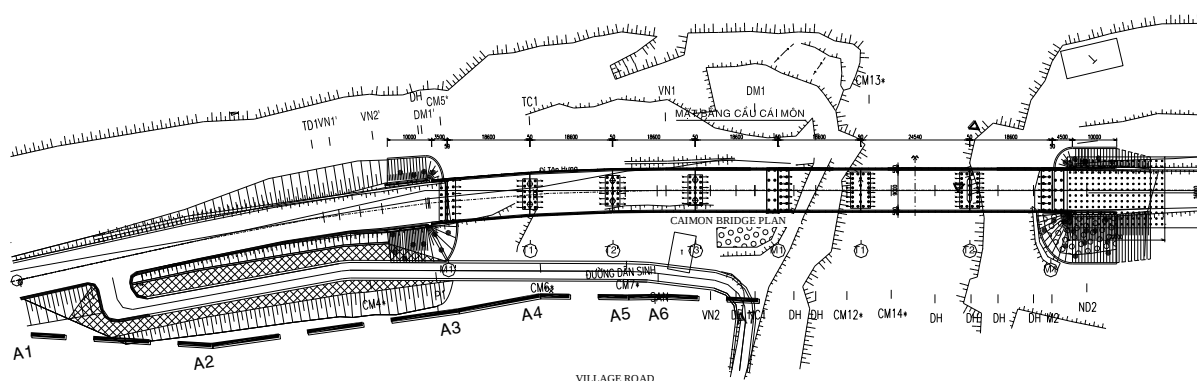
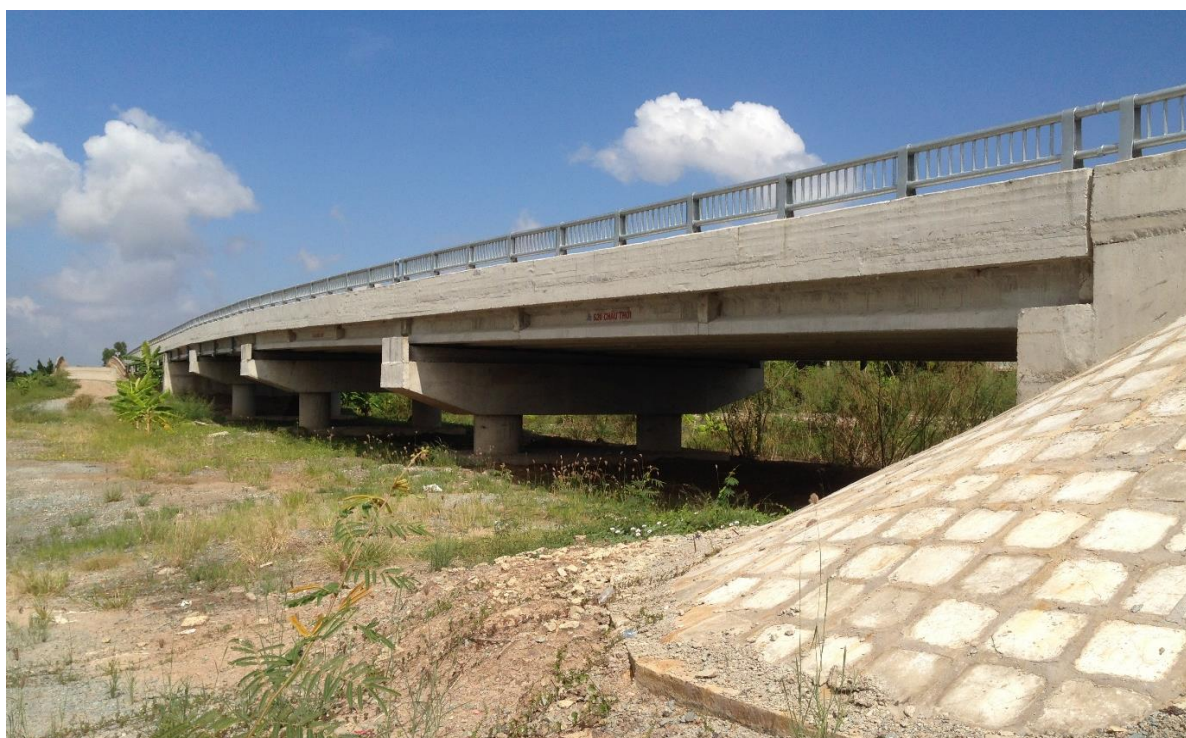
- Incident description: the bridge was designed with these details: width of 10m, prestressed reinforced concrete beams, reinforced concrete pile foundation. It had three spans: 18.6+24.54+18.6. The medium of approach way embankment high was 5m; the foundation of approach way embankment was reinforced in an area of 16x22m by cement earth piles ( $\Phi 600$ , L12m) with distance of 1.3m. The position of bridge was at the cross of Cai Mon River and 79 Canal. When they filled the embankment to the K98 sand layer (about 4m above natural land level), the M1 embankment slid into the 79 Canal of 75m in length, and the width was more than 20m.

- Reason of the incident: the thickness of weak soil is big. In this area, the clay mud layer is 9m medium and at M1 abutment, it increases to 20m. Besides, the fill of approach way was more than 5m to the existing land level, the construction was near river bank and at the cross of river and canal. The later survey showed that the bed of the canal was deepened more than 2m and this was not updated in the design. Along with the above reasons, the designers did not calculate land

slide.

- After analysis of economy and technique, the proposal of four spans extension was selected. The decision was based on cost effectiveness, design, work condition and old slide effect when they continued to reload the approach road way. The bridge was extended 4 spans of 18.6m. The construction treatment finished in 2015 and it is now in good condition (see figure 9-11).

**Figure 9.** Section of Cai Mon bridge treatment

**Figure 10.** Plan of Cai Mon bridge treatment

**Figure 11.** Four spans extension of Cai Mon bridge (M1 abutment)

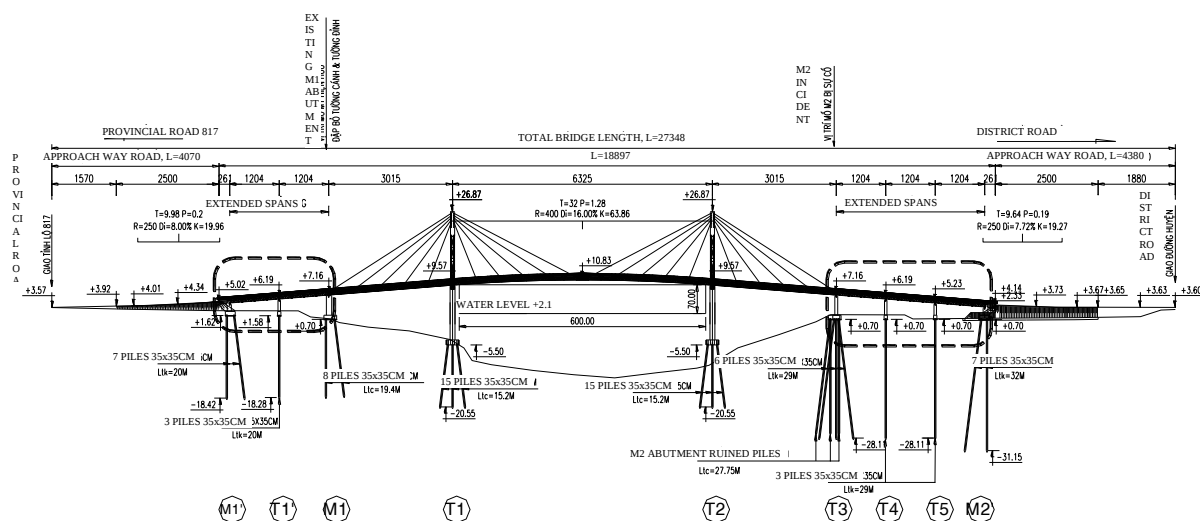
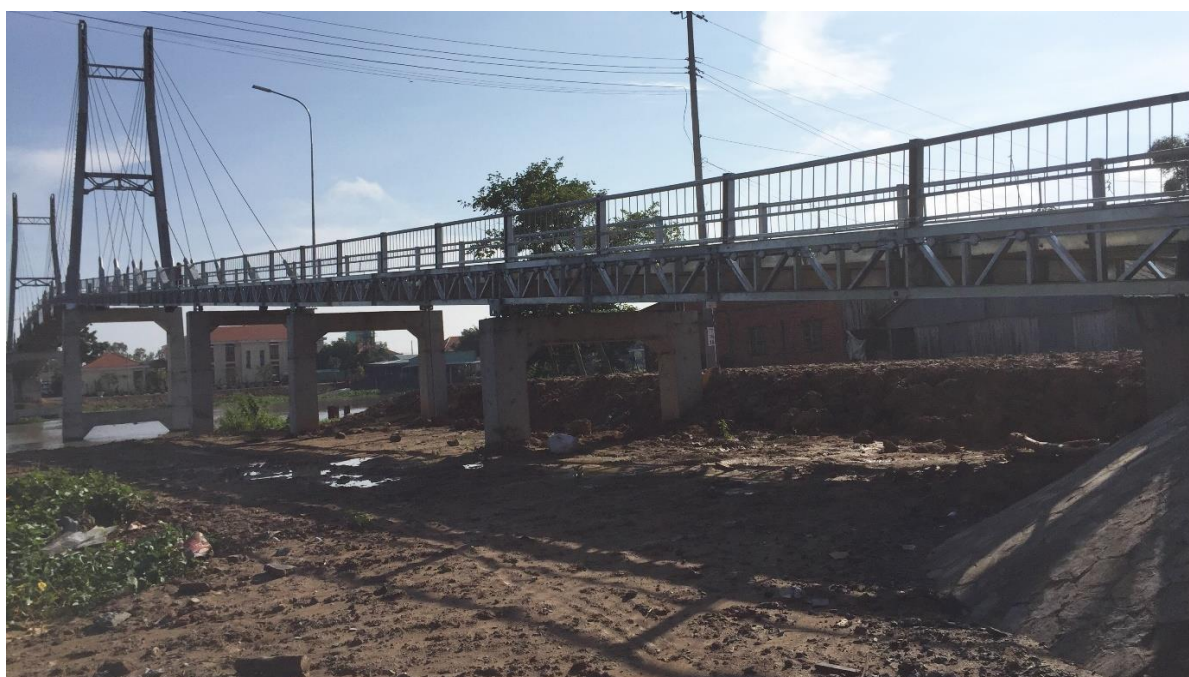
- The Binh Phong Thanh bridge is a suspension bridge built across Vam Co river. At first, the bridge had 4m width in plate steel, three spans (30-60-30m); two abutments were planned as pile and plank retaining walls for approach road ways. When they built abutment and load A embankment to level +5, it caused a slide circle with its width of 15m to the land. The land slide brought about the overturn of A abutment, the retaining wall

inclined to approach way. The cause was determined by many reasons: load of high embankment, near river position of abutment, thick layer of weak soil, design engineers did not calculate land slide, and there was no careful geologic survey.

- The solution: the bridge was extended two spans of 12m for B abutment (it had not yet incident), three spans of 12m for A abutment, the level of embankment is +4 (see figure 12-13). After reconstruction, the bridge was exploited in late 2016.

Figure 12. Section of Binh Phong Thanh bridge treatment

Figure 13. Abutment of Binh Phong Thanh bridge after treatment

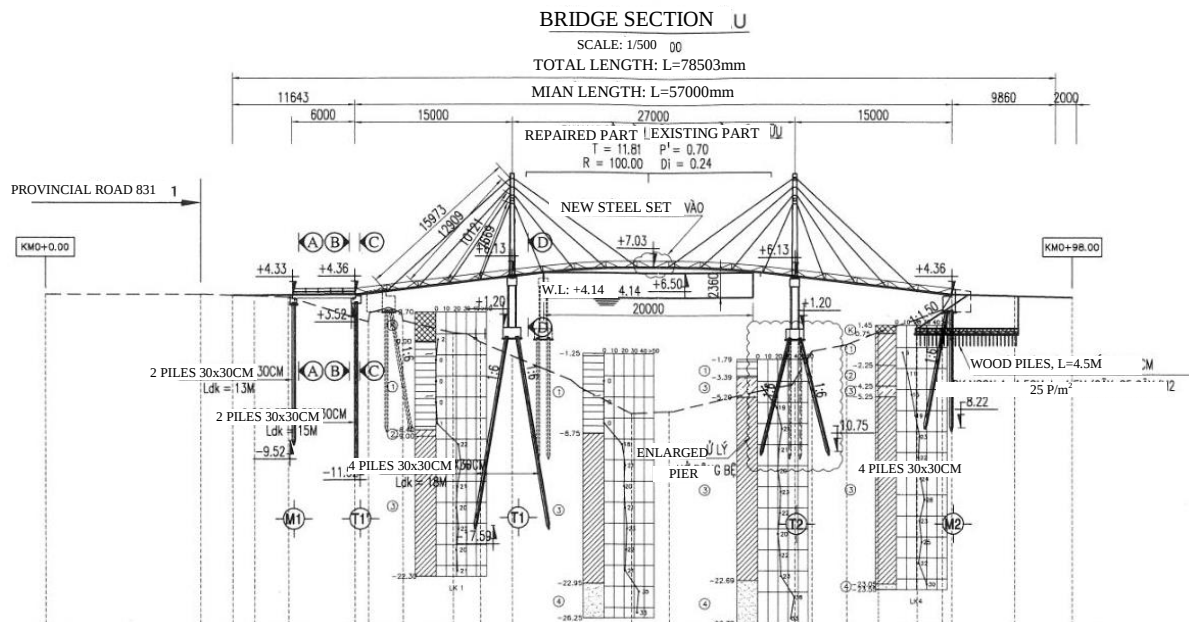
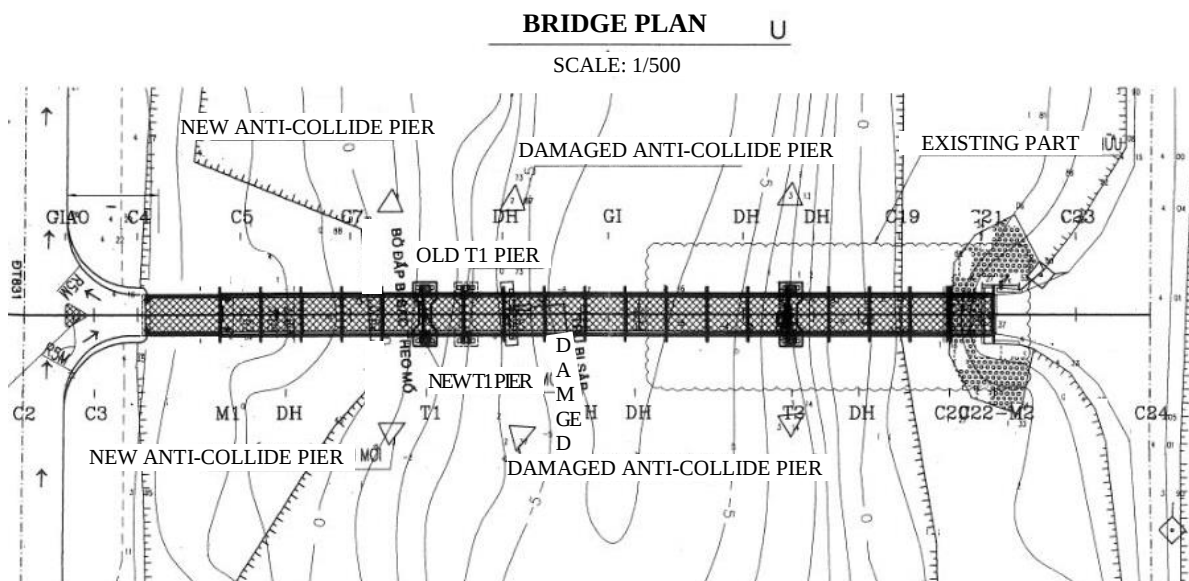
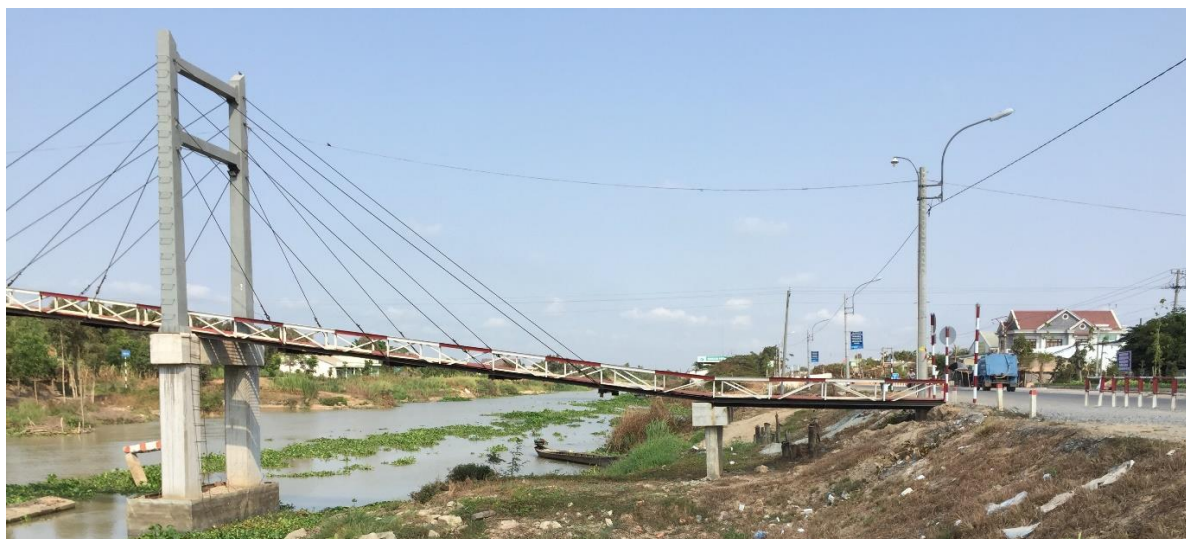
- The incident is similar to Binh Phong Thanh bridge. It was also a suspension bridge with three spans (15-24-15m), its width was 3.8m. The bridge had two piers, two abutments that were designed as pile retaining walls for approach ways. The design was based only the topographic data, and there was no

geographic survey. This situation has a thick layer of mud clay and at M1 abutment (along Provincial road 831) there was a land slide five years before. The bridge was unfinished then at M1 abutment, there was a land slide along Provincial road 831, the length was 50m, width of 10m. The pressure of land slide overturned the M1 abutment, the retaining wall inclined to approach way, the T1 pier also inclined.

there was a thick mud clay layer at bridge, along with the high fill level of Provincial road 831 and approach road way, near the canal. At construction, it occurred a land slide years ago and engineers did not calculate land

- Treatment way: they rebuilt T1 pier, built new T'1 pier, new M1 abutment, extended a span of 3m to connect T'1 pier and new M1 abutment (see figure 14-16).

**Figure 14.** Section of Vinh Binh bridge treatment

**Figure 15.** Plan of Vinh Binh bridge treatment

**Figure 16.** Position of Vinh Binh bridge incident after treatment
